Building Limes Forum Ireland is a community of lime practitioners, specifiers, suppliers and producers of lime. The Forum exists to encourage expertise and understanding in the appropriate use of building limes, and education in the standards of production, preparation, application and aftercare. Building Limes Forum Ireland is connected and affiliated to the Building Limes Forums across the world.

Slate Hung Walls - South Mall, Cork City

Context

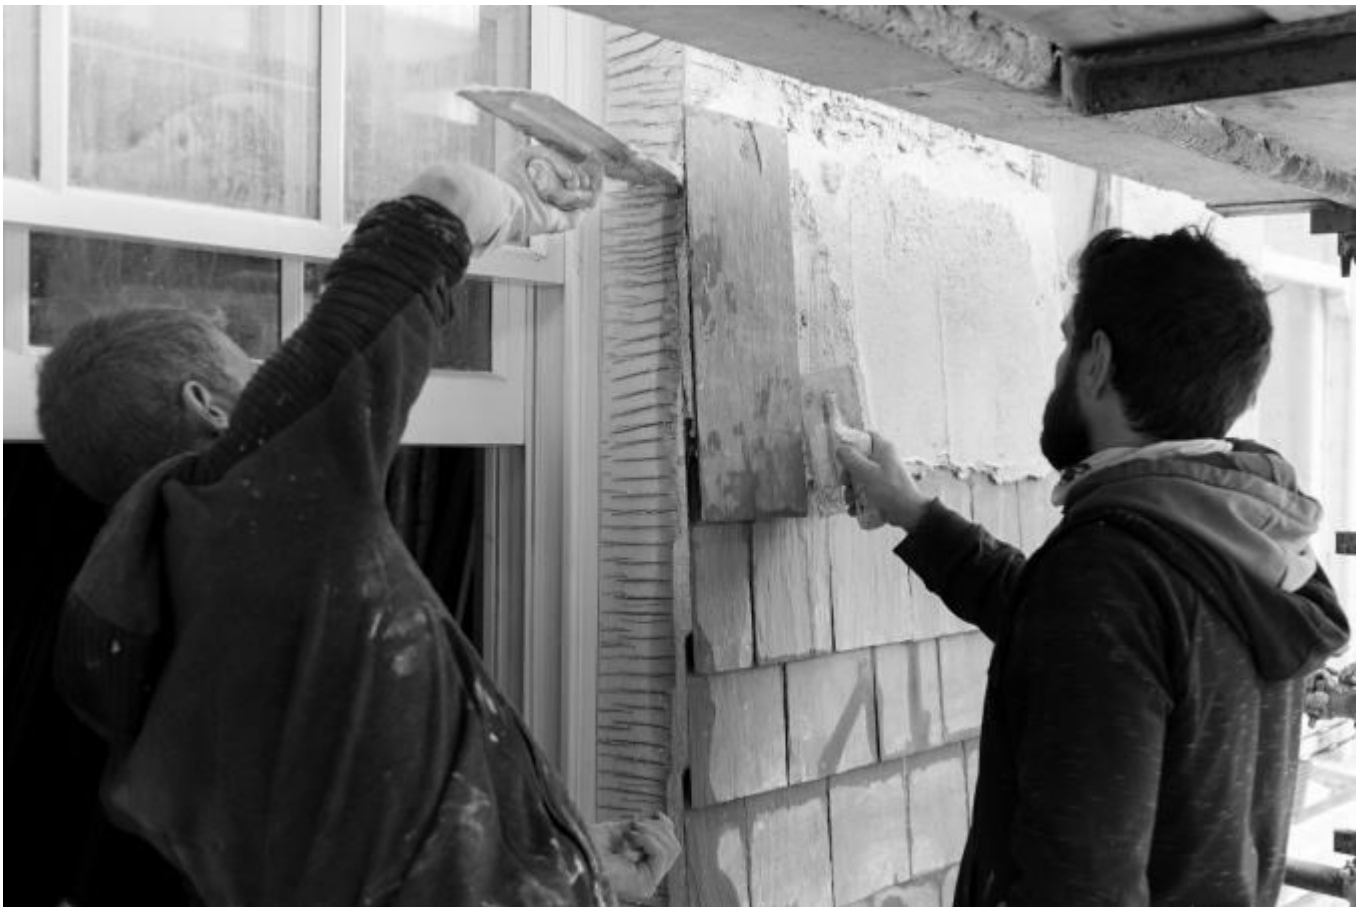
Hung slates being installed by Will and Mick of O'Brien and Donnellan Builders in 2021, by Andrew Campion Photography.

Installing hung slates required a lot of consideration. Financially, the supply of the slates was an addition to the cost of the project. Legally, there was a consent process as the change from the rendered wall back to hung slate required planning permission. Technologically, there was a method to be developed. This included producing exemplar panels, visiting extant local examples, preparing setting-out drawings, and refining a method statement.

Certain features are essential to the achievement of an authentic hung slate façade. We observed distinctive characteristics from visiting and studying local precedents. Each slate course has a sharp horizontal shadow line. As with many traditional motifs, how the light falls on the surface is an important consideration. The horizontal coursing varied from a mean of 180 mm with variants of between 170 mm and 190 mm. This variant gave flexibility when aligning coursings to heads, sills, and string courses. These dimensions also matched the coursings from the archival photographs. The vertical butt joints have a minimal gap, at most 3 mm, reinforcing the dominant horizontal line. Traditionally hung slates do not form a perfect grid, which is ideal as it has inherent flexibility. As the slates varied in size, we devised a cutting schedule that minimised waste to near zero. Standard slates 300 mm wide and 500 mm high were cut down into varying widths. These ranged from equal divisions of two 150 mm sections to unequal divisions such as 170 mm and 130 mm or 225 mm and 75 mm. The narrower slates could be used as full or half slates. We superimposed a setting-out drawing on a local precedent, 2 Dyke Parade, to get the sizing correct. We devised a lap joint for the window head that maintained the sharp coursing line. This allowed the mortar on the head reveals to be rendered into a backing slate with the facing slate lapped over.

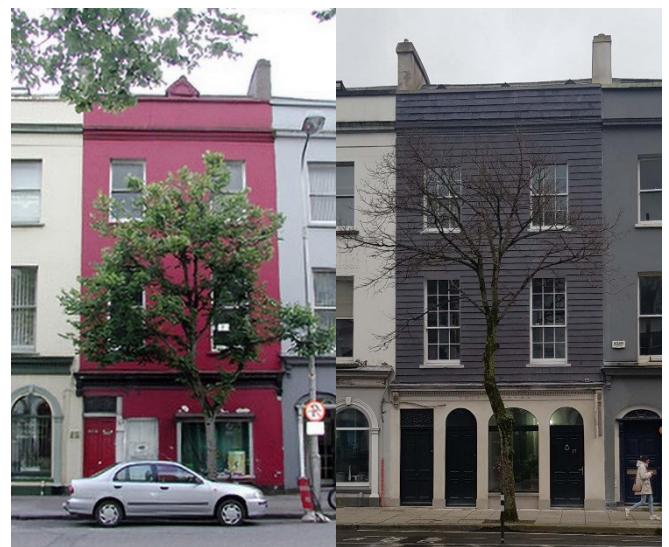
No.37 South Mall prior to works (left) credit NIAH, and on completion (right).

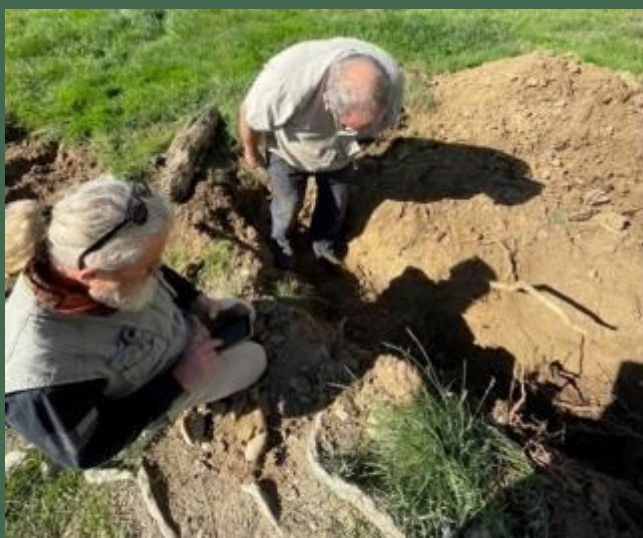
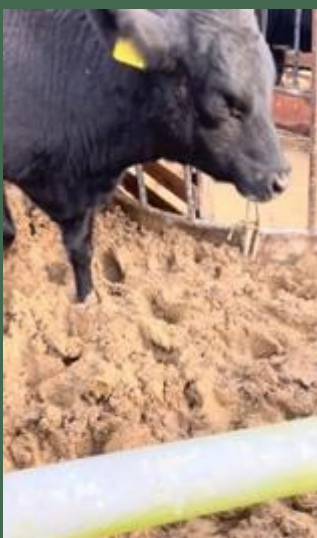
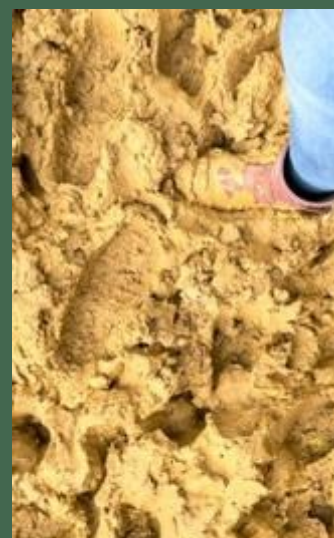
Left - David Ffrench and Patrick Hickey assessing the fourth test site displayed a small percentage of marl, which is required to form a compatible mix. Middle - Cattle treading the mortar, Right - Treading by foot.

The aim of the project was to stabilise and arrest deterioration of the structures in a sustainable and conservation focused approach to preserve the character and integrity of the vernacular setting. Over three quarters of the repair materials were sourced from the farm itself, which included clay, wood and straw. Growmax in kibble form (quicklime) was used as the main binder for pointing, rendering, and limewashing with aggregate sourced from a local quarry. The availability of a fine head of cattle was not lost on the project team with the kneading of the clay achieved by driving hand reared bullocks through the mix in a controlled environment and under the skilful husbandry of Mr Ffrench.

Once the mix had tempered the clay was laid on in layers of twelve to eighteen inches, ensuring a slight overhang. The layer was beat down before leaving it to set (one to two days subject to the weather) with the area covered during this time in a layer of fine Wexford straw and twigs to protect it from the elements. Once the previous day's work was sufficiently firm the next layer was added leaving the straw in place to assist in binding the subsequent layer and with the twigs repositioned horizontally, forming a dowel for added strength (not a thing was wasted!). On completion of a new layer, the overhang to the previous layer was carefully pared back. The finish surface was left rough to achieve a bonding surface with a final lime-wash applied by Mrs. Ffrench herself who traditionally carries out whitewashing twice yearly on Good Friday, and the last day of Harvest. Mr. Ffrench advises that following the project Mrs. Ffrench has vowed to change her limewash mix from a Rhino lime to a Kibble Quicklime mix!

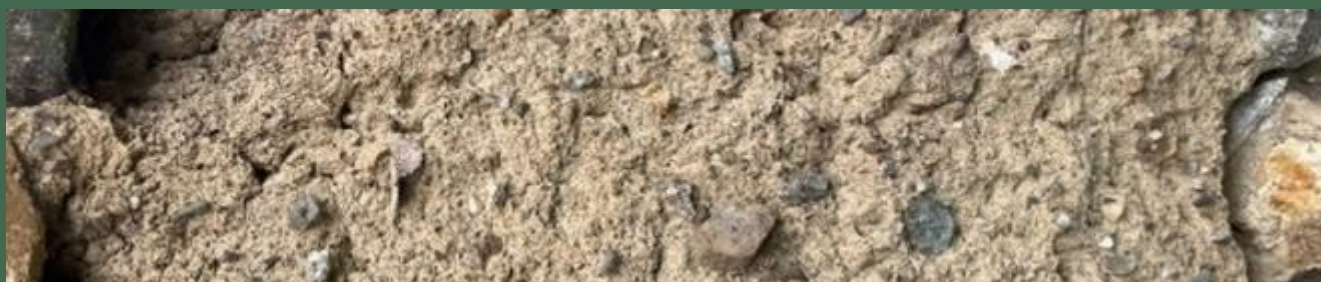
Eroded tempered clay exposing aggregate.

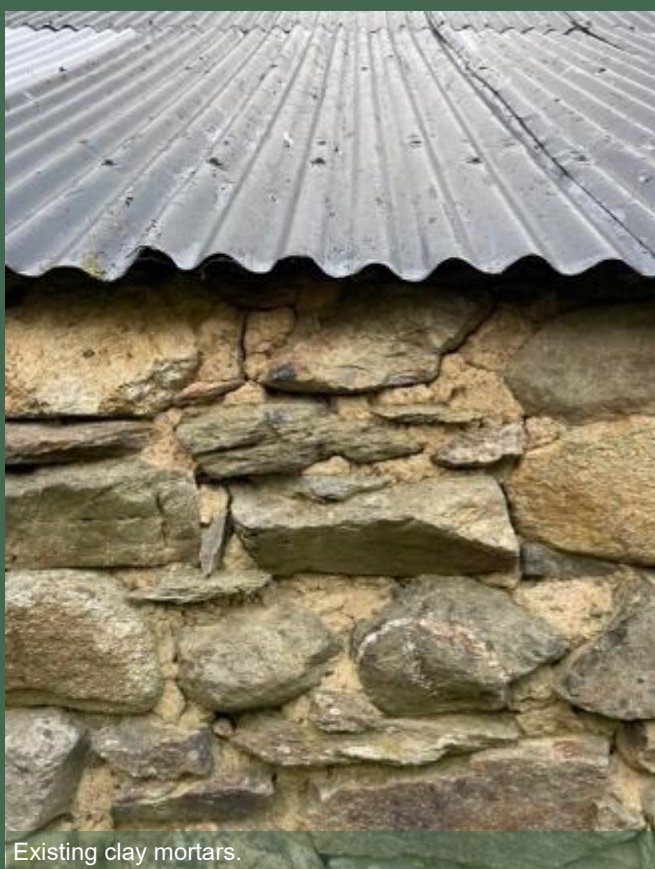
Existing clay mortars.

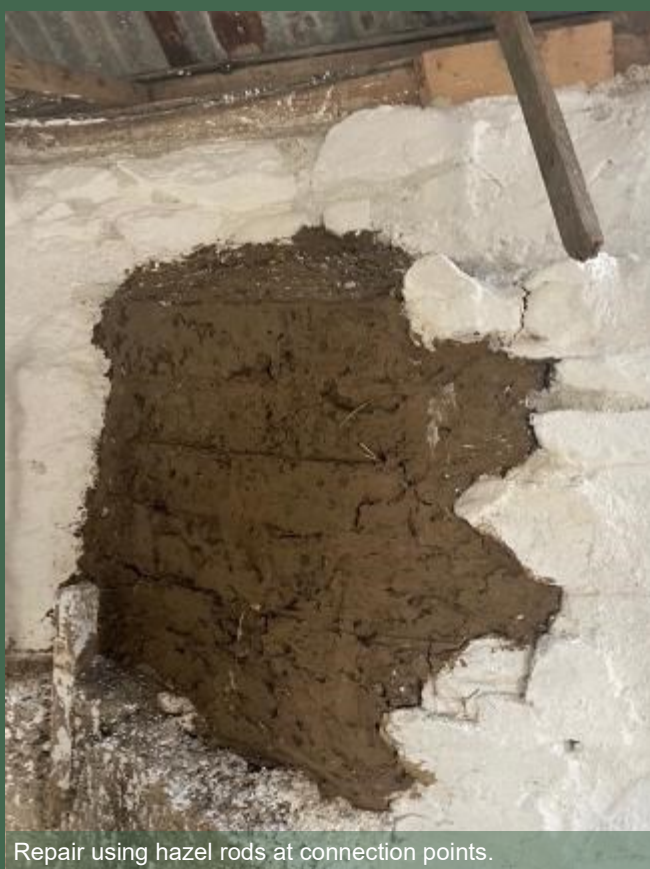
Repair using hazel rods at connection points.

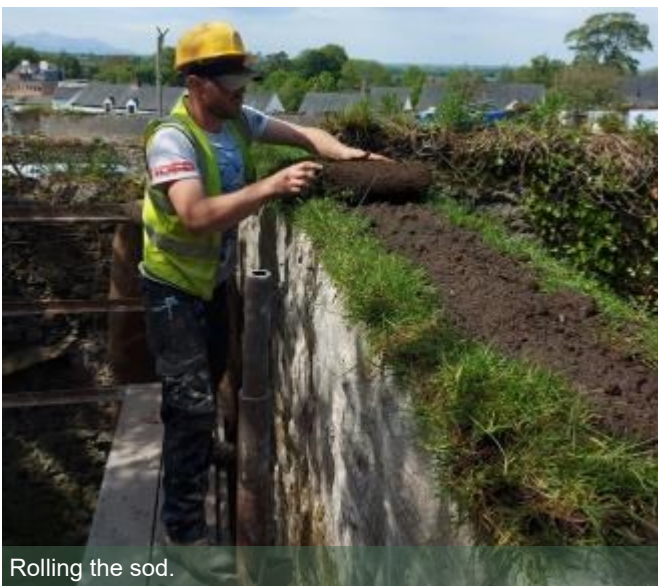
Rolling the sod.

To make a 'hungry soil' we mixed local soil, found adjacent to the site, with 'Rabbit' sand (a sand rarely used by plasterers or block layers.) The works were carried out to the following methodology:

- Mix clay and aggregate at a ratio of 5 parts clay to 1 part sand.
- Lay clay mix to centre of wall top – in some cases where the heaving to the wall has failed or where localised re-

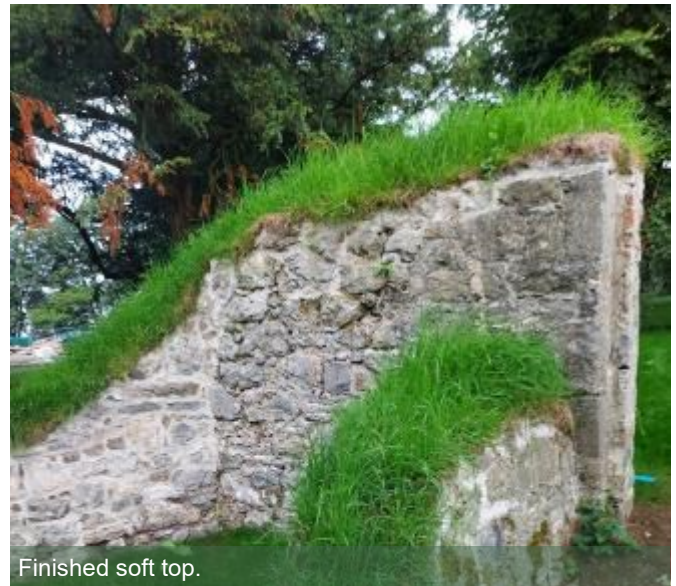
Finished soft top.

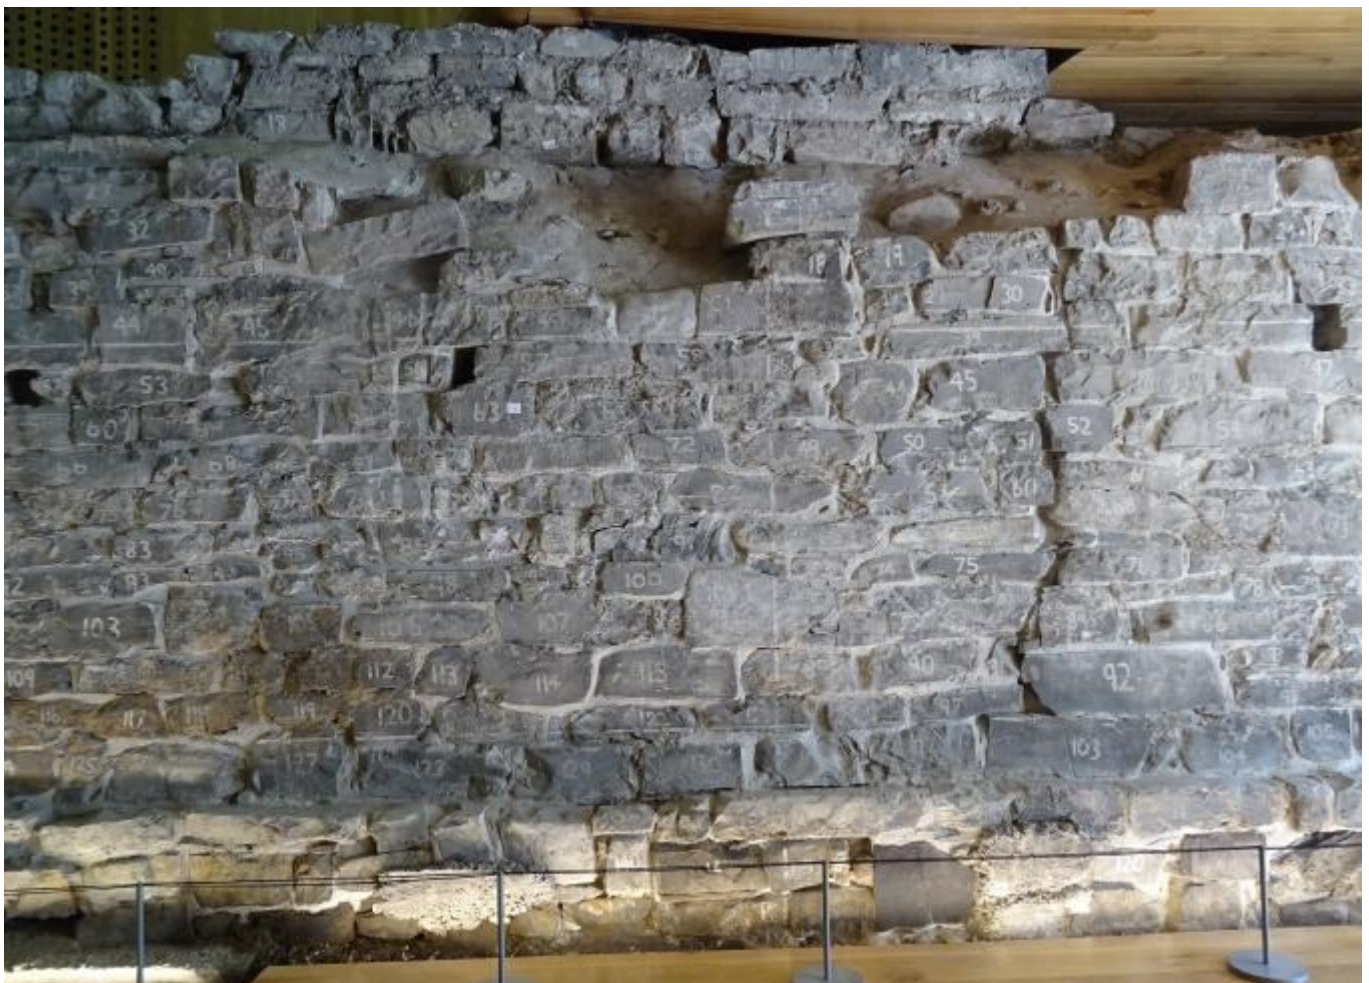
Dublin city wall following completion of the works.

Where historic pointing was found to be sound it was retained in situ and repointing was carried out around it. The mix and finish of the repointing was chosen and carried out so that the pointing gave a uniform appearance to the wall overall while allowing identification of the historic pointing on closer inspection.

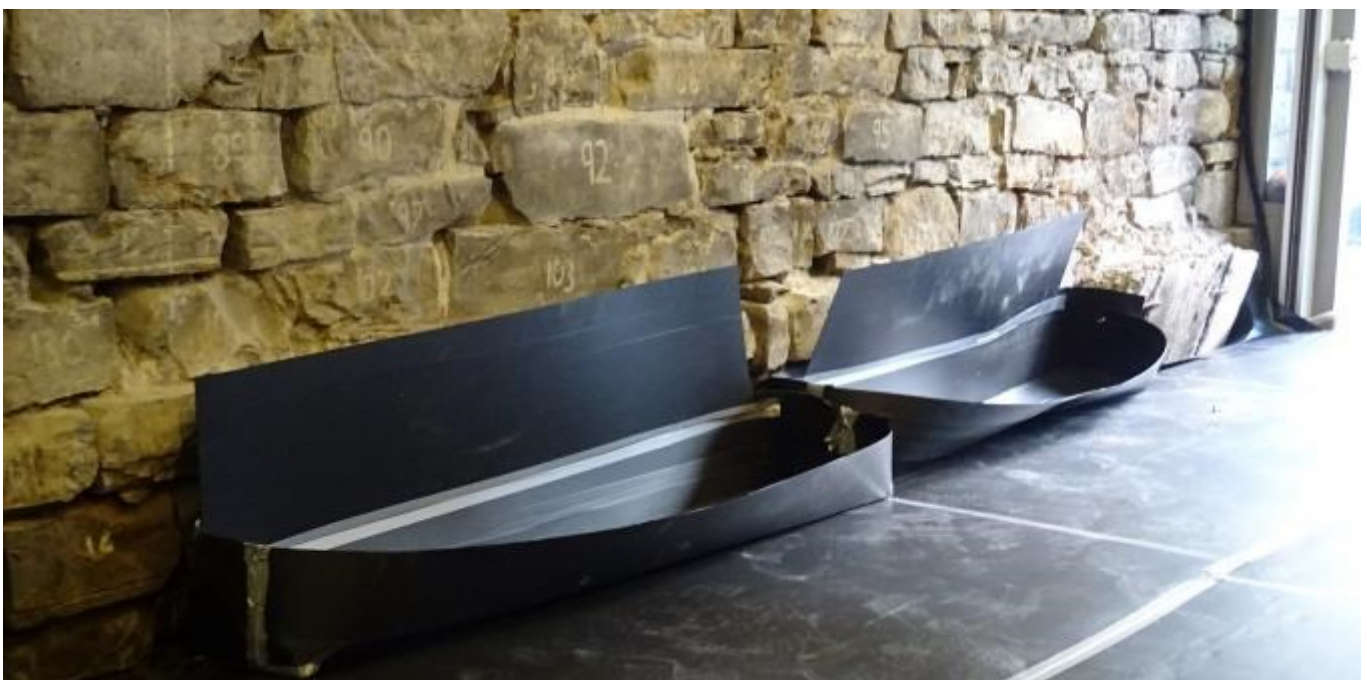
Material from the raked out joints was collected and processed.

As each section was raked out the material from the raked out joints was carefully collected and processed and the aggregate was sieved for reuse in that area. The raked out material was collected in trays at the base of the wall. Once any archaeological material had been identified and processed, the remainder of the material collected was sieved and the graded material was reused as aggregate. The processed aggregate was incorporated into the mortar mix which was used to repoint the section from which the aggregate had been raked out.

Some of the joints had failed to a considerable depth. In places bedding mortar had to be replaced as well as the pointing. Where joints were particularly deep these were repointed in phased stages.

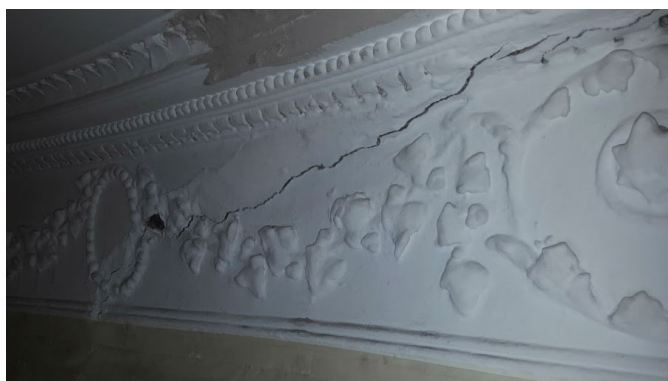
Frieze to Goethe Institute prior to works.

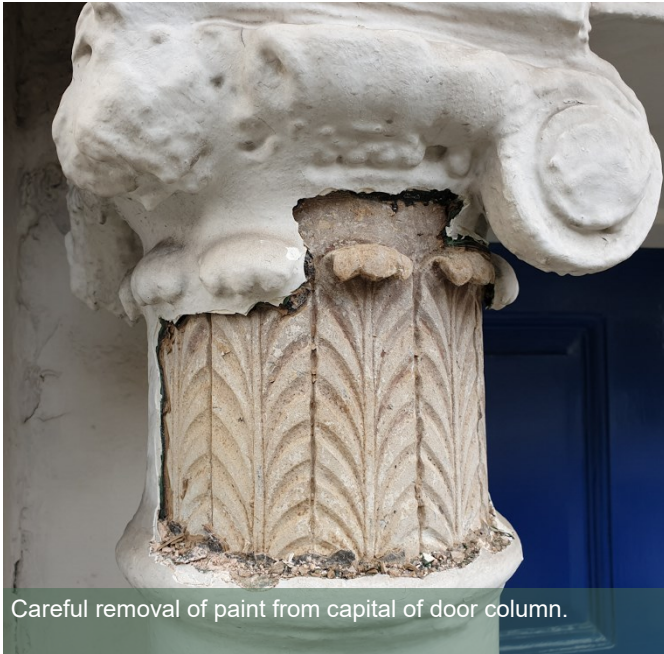
Careful removal of paint from capital of door column.

Of course, the overpainting of detailing is not merely confined to the decorative plaster cornices and centre pieces of internal rooms. Columns which frame the main entrance door to the United Arts Club were a mere vestige of their former glory. Here we undertook similar paint removal followed by the conservation and restoration of the volutes. The same rules applied - you have to know what you are doing, or serious damage could occur, but when carried out correctly and sensitively you can begin to appreciate the detail with which these elements were originally intended. Similar works were undertaken to areas of overpainted masonry elements in the rear courtyard which was once was an underutilized space and is now a beautiful area for outside dining (a welcome and inviting space during the pandemic).

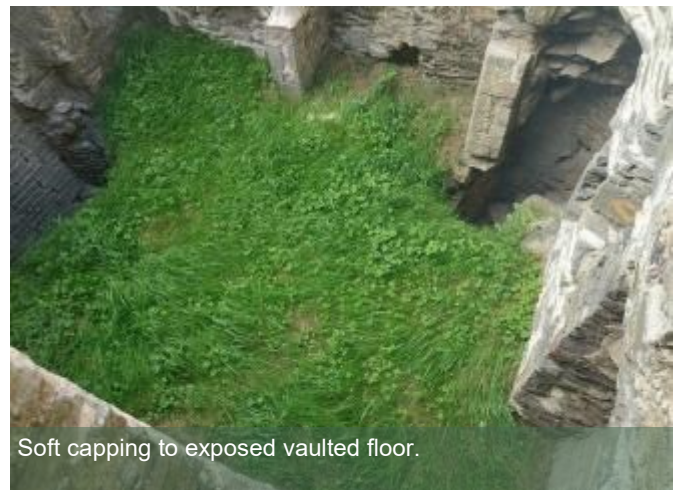
Soft capping to exposed vaulted floor.

sional masonry collapse, the vaulted first floor lost its integrity and partially failed, strewing masonry on the ground floor beneath. As part of the conservation works at Stella's Castle, collapsed masonry elements, to include those to the skyward surface of the vaulted floor were gathered and stored externally in gabions. The exposed crown of the vault and its broken edges presented a particular challenge with regards to consolidation and weathering against elements. Here the design team seized the opportunity to employ an innovative, conservation solution – soft-capping. A site specific specification was developed by DKP for Stella's Tower, whereby locally harvested sods were pinned into a layer of applied puddle clay. The installation is designed as a low impact and fully reversible grassed 'roof', providing natural protection to the otherwise exposed fabric of the ruin.

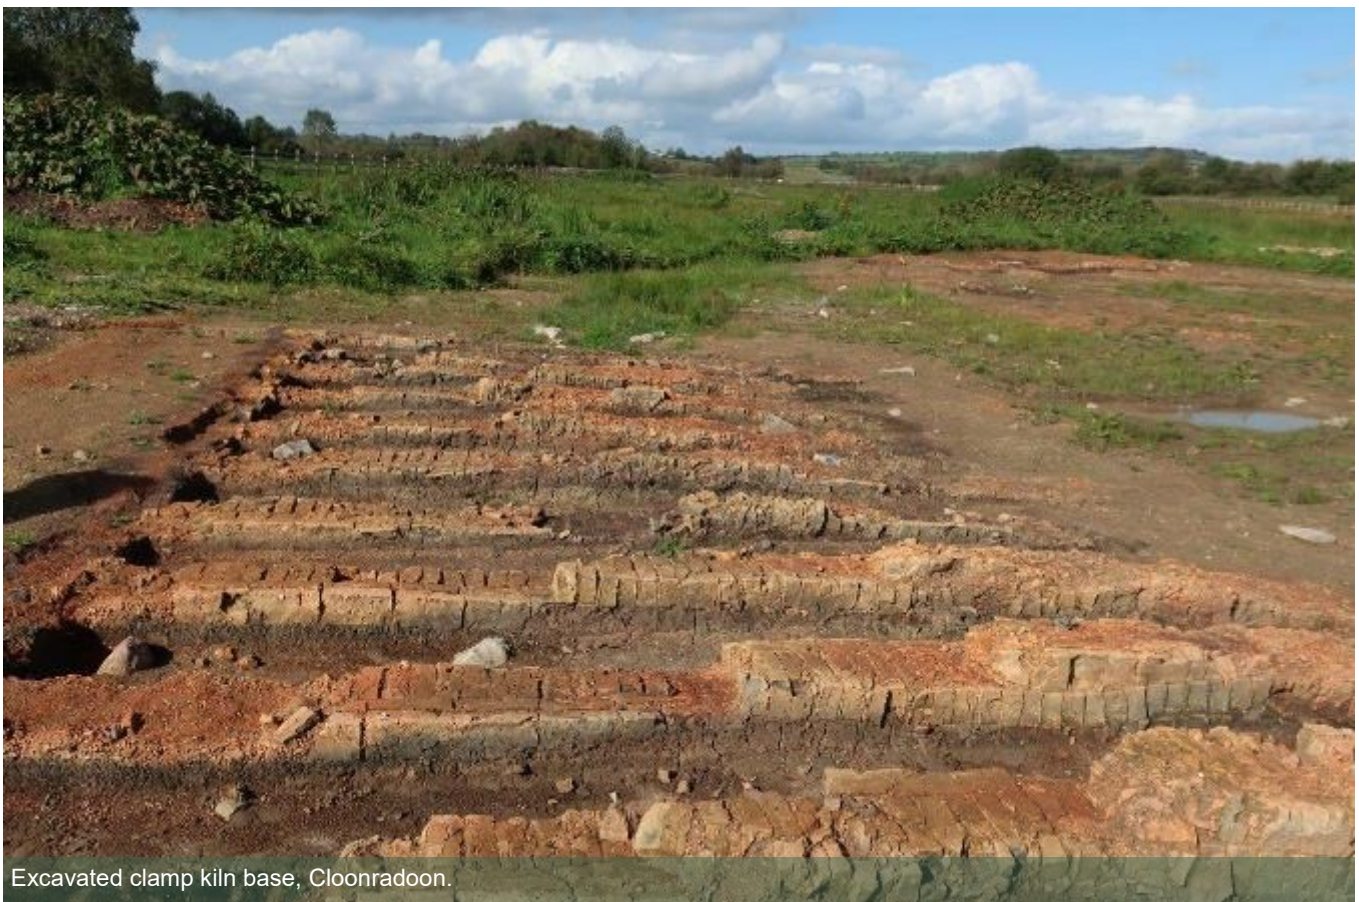
Excavated clamp kiln base, Cloonradoon.

While there is plenty of documentary evidence of this sort of estate brickmaking, few sites like this have actually been excavated. One similar site was discovered at Abbotstown, Co. Dublin, in 2013. Here excavations associated with the National Sports Campus revealed the base of a brick kiln on the grounds containing brick that similarly was an exact match for the red brick in the walled garden. [Coughlan, Sheephill, Dublin, 2013] ‘

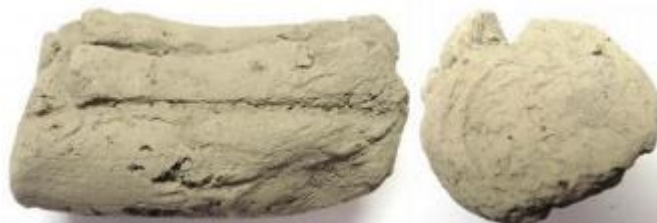
Unburnt culm bomb.

Burnt culm dust to recap is comprised of fine anthracite particles from local and now ceased coal mining activity. Early evidence for the use of culm can be identified as far back as the medieval period. Up until quite recently it was mixed 1:7 with local yellow clay into small units that, once dry, were used as fuel in counties Tipperary, Carlow and Kilkenny. Indeed, it is known that large amounts of culm had been exported to the UK, at a time, for industrial fuel use. Culm and clay, when mixed are called "Culm Balls" or "Culm Bombs" and when burnt they create intense heat which vitrifies the clay content just like in brick production. The burnt "Culm Balls" or "Culm Bombs" hold their original form, though they crush and powder with great ease unlike historic bricks.

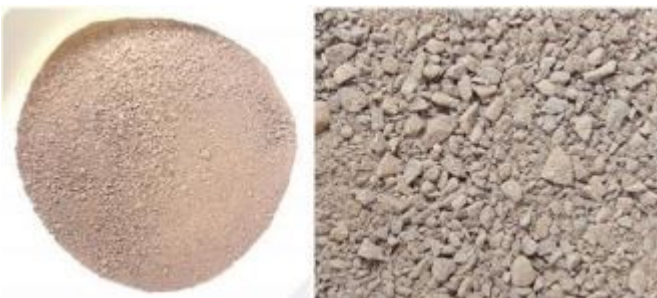
Crushed basalt.

Basalt being part of our geology was another avenue to pursue. On examining basalt it comprises of 66% silica and alumina. It is available crushed here in Ireland and is very affordable. Culm took some hunting down, but that in itself proved very valuable by way of the people I met and their advice on mixing and use. Once sourced it proves to be abundant.
